IMPACT RESISTANCE OF
COMPOSITE FAN BLADES

E. J. PREMONT
K. R. STUBENRAUCH

PRATT & WHITNEY AIRCRAFT
DIVISION OF UNITED AIRCRAFT CORPORATION

1. Report No. NASA CR-134515		2. Government Accession No.		3. Recipient's Catalog No.	
4. Title and Subtitle Impact Resistance of Composite Fan Blades Final Report				5. Report Date May 1973

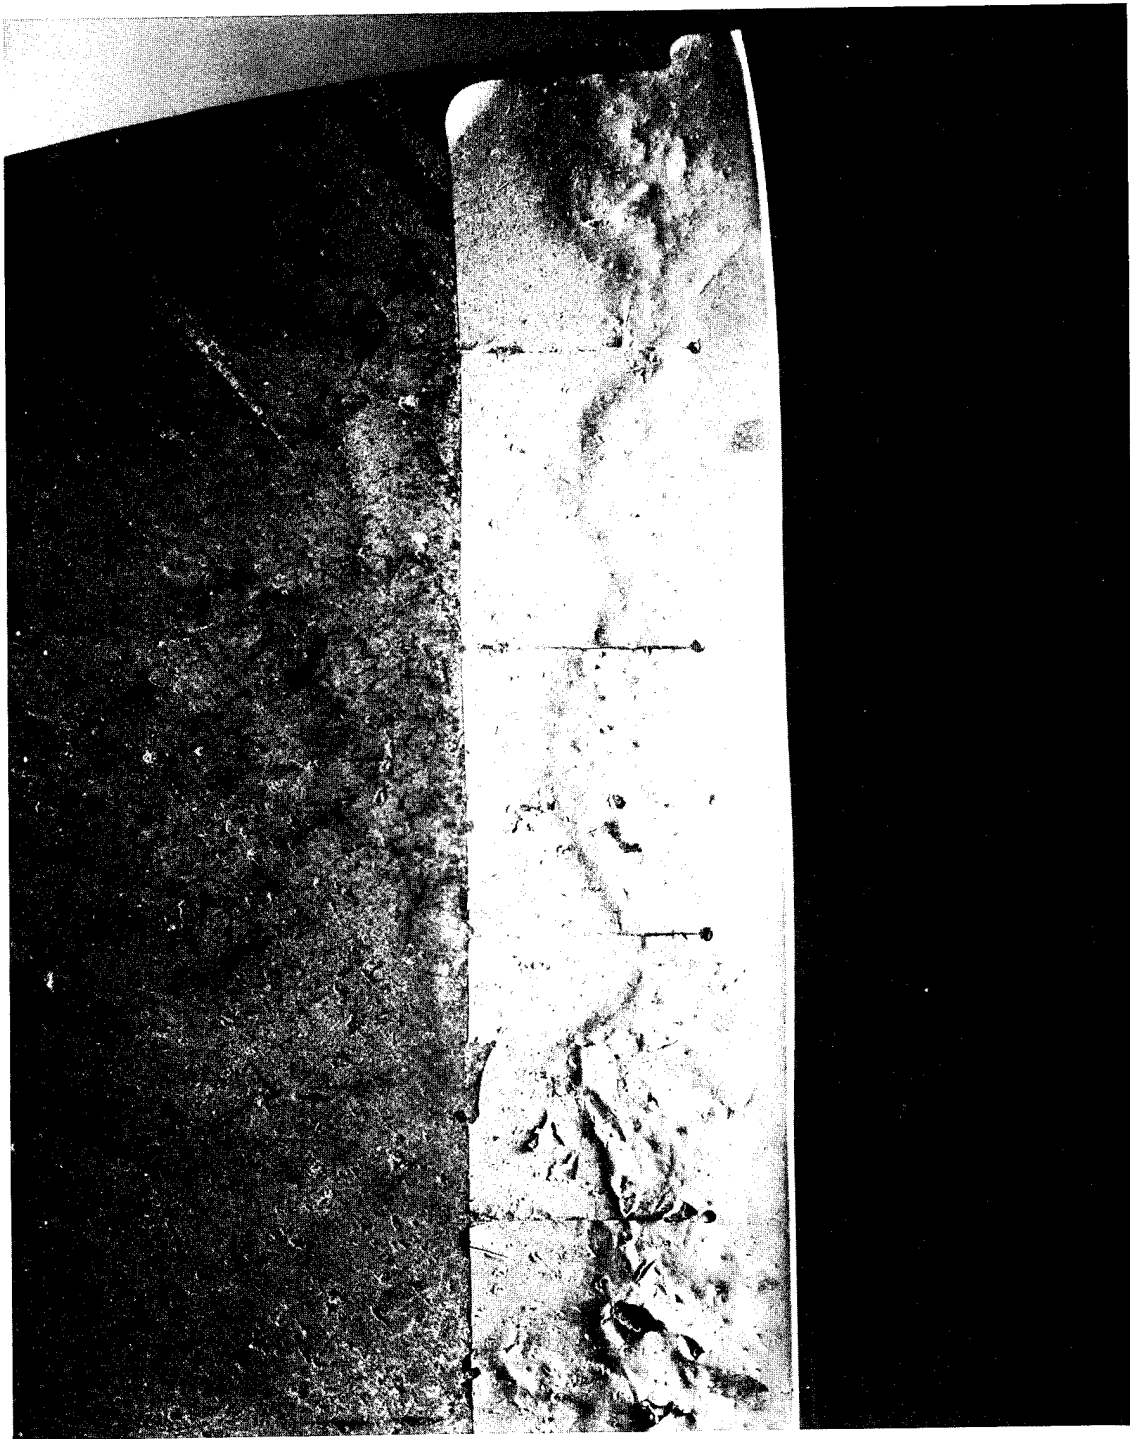
The gravel impact results on blade B-4 are shown in Figures 47 and 48. No ultrasonic indications were found after testing. Damage at the leading edge is negligible, even though the high-speed movies show that impacts did occur at this location. However, the concave side sheath, aft of the leading edge, was nicked, gouged, and unbounded, as pictured in Figure 49. The gravel apparently strikes the sheath causing compressive stresses on the sheath exterior surface. The stress differential within the sheath is great enough to break the sheath-to-blade bond and then lift the sheath from the surface of the blade. Therefore it is concluded that with a better bond between sheath and blade, the leading edge sheath could offer satisfactory protection from small amounts of gravel ingestion.

Figure 49 Boron/Epoxy Blade B-4 Following Impact with Gravel
